**Clean Harbors PPM, LLC Coffeyville Facility  
Corrective Measures Implementation  
5-Year Review Report  
RCRA ID# KS981506025**

**Subject: Corrective Measures Implementation 5-Year Review Report  
Clean Harbors PPM, LLC, Coffeyville, Kansas Facility  
RCRA ID# KSD981506025**

# Clean Harbors PPM, LLC Coffeyville Facility Corrective Measures Implementation 5-Year Review Work Plan RCRA ID# KS981506025

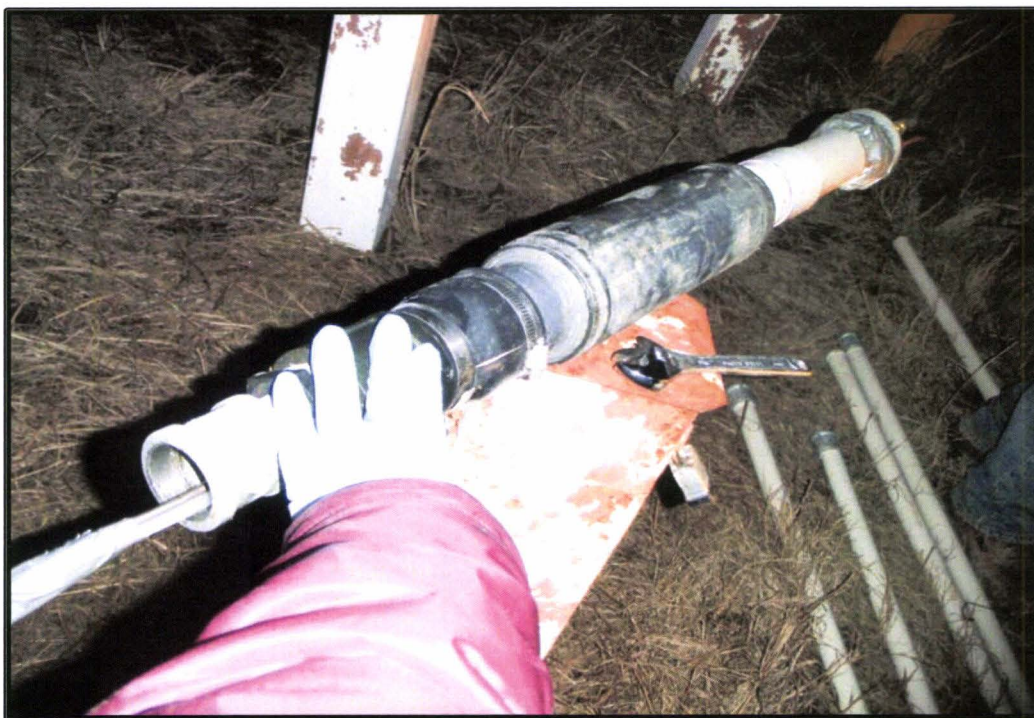
FIGURE 3-2

After baseline water quality parameters had stabilized, approximately 1 to 5 milliliters (mL) of the KCl solution was added to the recirculating groundwater. The valve to the tracer reservoir was then closed and field parameters monitored by the YSI meter and recorded in 2-second intervals. A spike in electrical conductivity was observed in each dilution test approximately 10 minutes after the solution was introduced to the well. Based on the amount of solution added, the spike ranged from 0.1 to 2.4 microsiemens per centimeter squared ( $\mu\text{S}/\text{cm}^2$ ). Water quality parameters were recorded at regular intervals until electrical conductivity returned to its baseline value or the test was stopped.

(a) Schematic of the Downhole Portion of the Point Dilution Apparatus  
 (b) Schematic of the Recirculation Cell of the Point Dilution Apparatus

Downhole Portion of the Point Dilution Apparatus in the Field

A successful test was completed in well IW1-5. For this test, the initial conductivity of the tracer solution was  $231.2 \mu\text{S}/\text{cm}^2$ , and  $0.835 \mu\text{S}/\text{cm}^2$  for the baseline circulating downhole water. Upon injection of 5 mL of tracer solution, the downhole conductivity spiked to  $1.056 \mu\text{S}/\text{cm}^2$ . After approximately 10 hours, the downhole conductivity had changed to  $0.833 \mu\text{S}/\text{cm}^2$ , with the tracer being transported into the surrounding media and the circulating water returning to baseline conditions. Conductivity calculations and further analysis of this test are presented in Section 5.2.3.

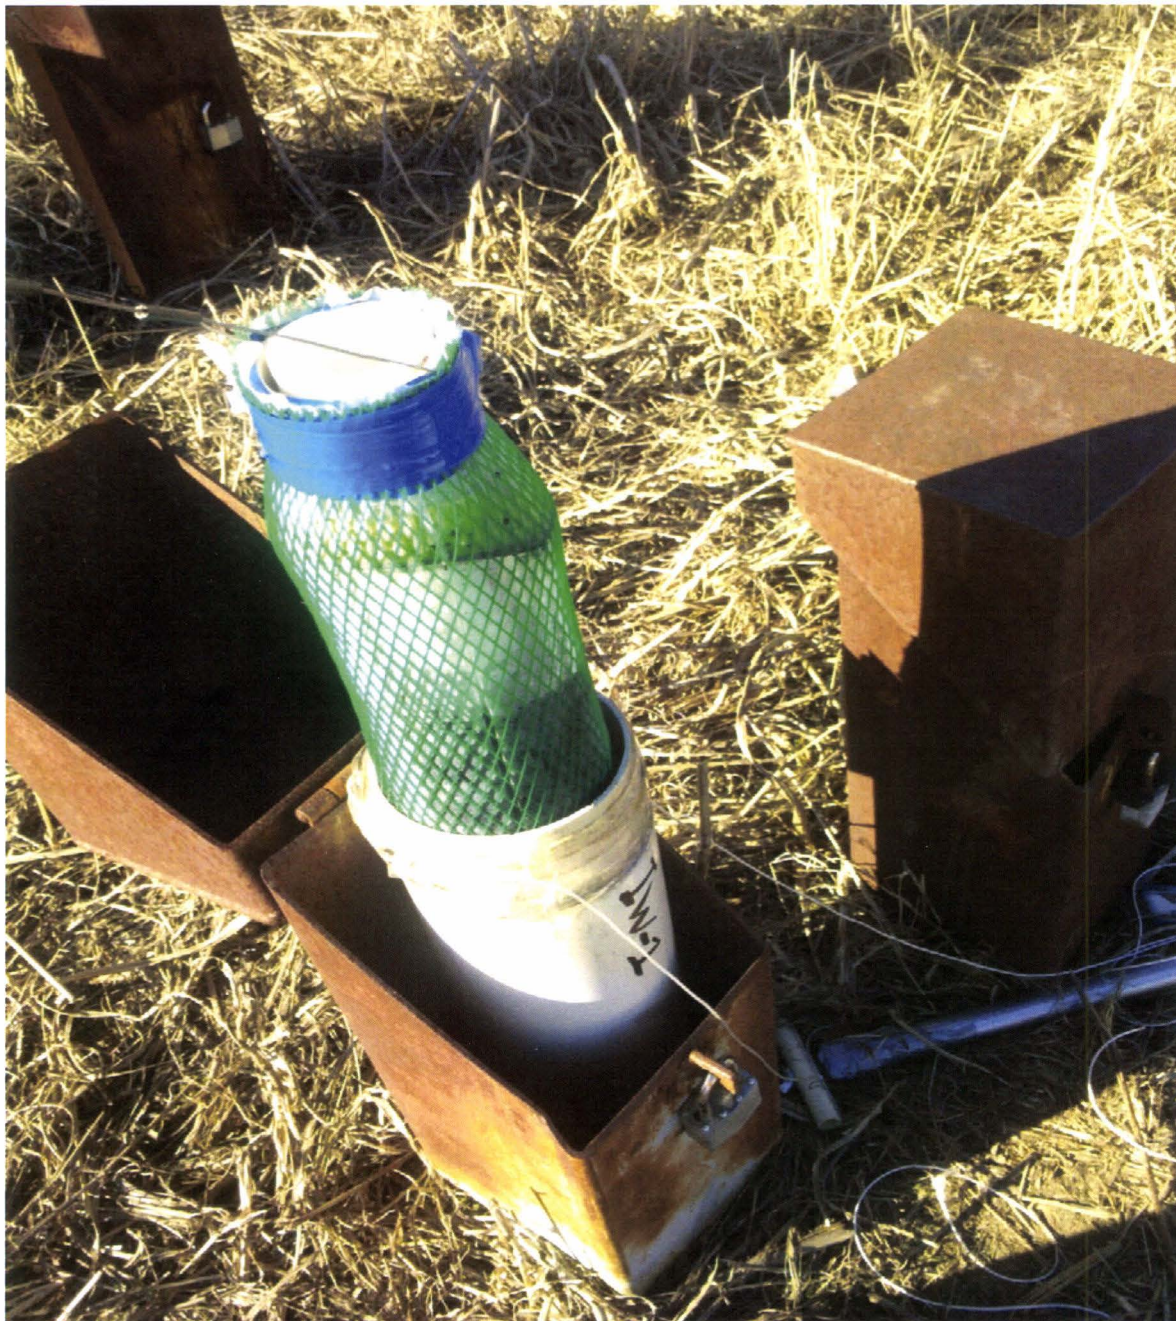
FIGURE 3-3

Each PFM was 5 feet long with a diameter approximately equal to the well diameter (**Figure 3-3**). Two PFMs were emplaced in each test well to span the screened zone and assess vertical variation in groundwater velocity. PFMs were successfully emplaced in two new monitoring wells in the Phase I Gate (M-10 and M-11), one existing well in Phase II Gate 1 (IW1-5) (**Figure 2-6**), and two existing wells in Phase II Gate 2 (IW2-3 and IW2-4) (**Figure 2-6**). PFM installation was unsuccessful in Phase I Gate wells IW-1 and IW-2, which may be explained by bent or damaged casings or screens.

The PFMs were left in each well for approximately 10 days, after which they were pulled from the wells. The PFM in IW2-3 could not be removed because the wire hanger failed during retrieval. After the PFMs were removed, each sorbent sock was cut open and the activated carbon placed into clean stainless steel bowls. The sorbent media from the upper half of each PFM was separated from the material from the lower half. The material in each bowl was homogenized by stirring. The samples (two from each PFM) were then packed in special containers and shipped using standard chain-of-custody (COC) procedures to EnviroFlux for analysis. See Section 5.2.2 for a discussion of PFM testing results.

PFMs were retrieved from all test wells and analyzed, except for IW2-3, where the attached cable failed during retrieval. Each PFM consisted of two 5-foot-long vertical sections to determine velocity in two discrete vertical zones at each test location.

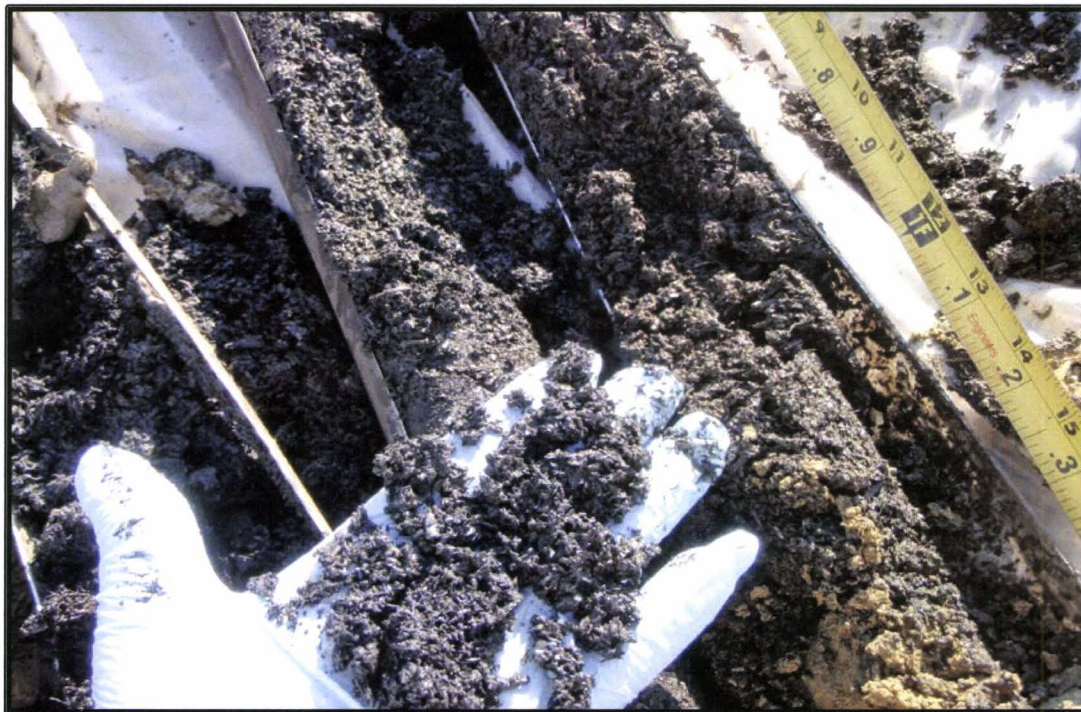
FIGURE 3-4

Samples of the ZVI and ZVI-sand media, respectively, were collected from borings drilled in the Phase I Gate on January 11, 2012, and Phase II Gate 1 on January 10, 2012. The boring in the Phase I Gate was approximately midway between the upgradient and downgradient faces of the ZVI. The boring in Phase II Gate 1 was several feet downgradient of the leading edge of the PRB, between IW1-1 and IW1-2. No visual signs of significant mineral precipitation were observed (see Figure 3-4).

Phase II Gate I Iron Filings/Sand Mixture

Iron Filings From Phase I Gate Monitoring Well install M-10

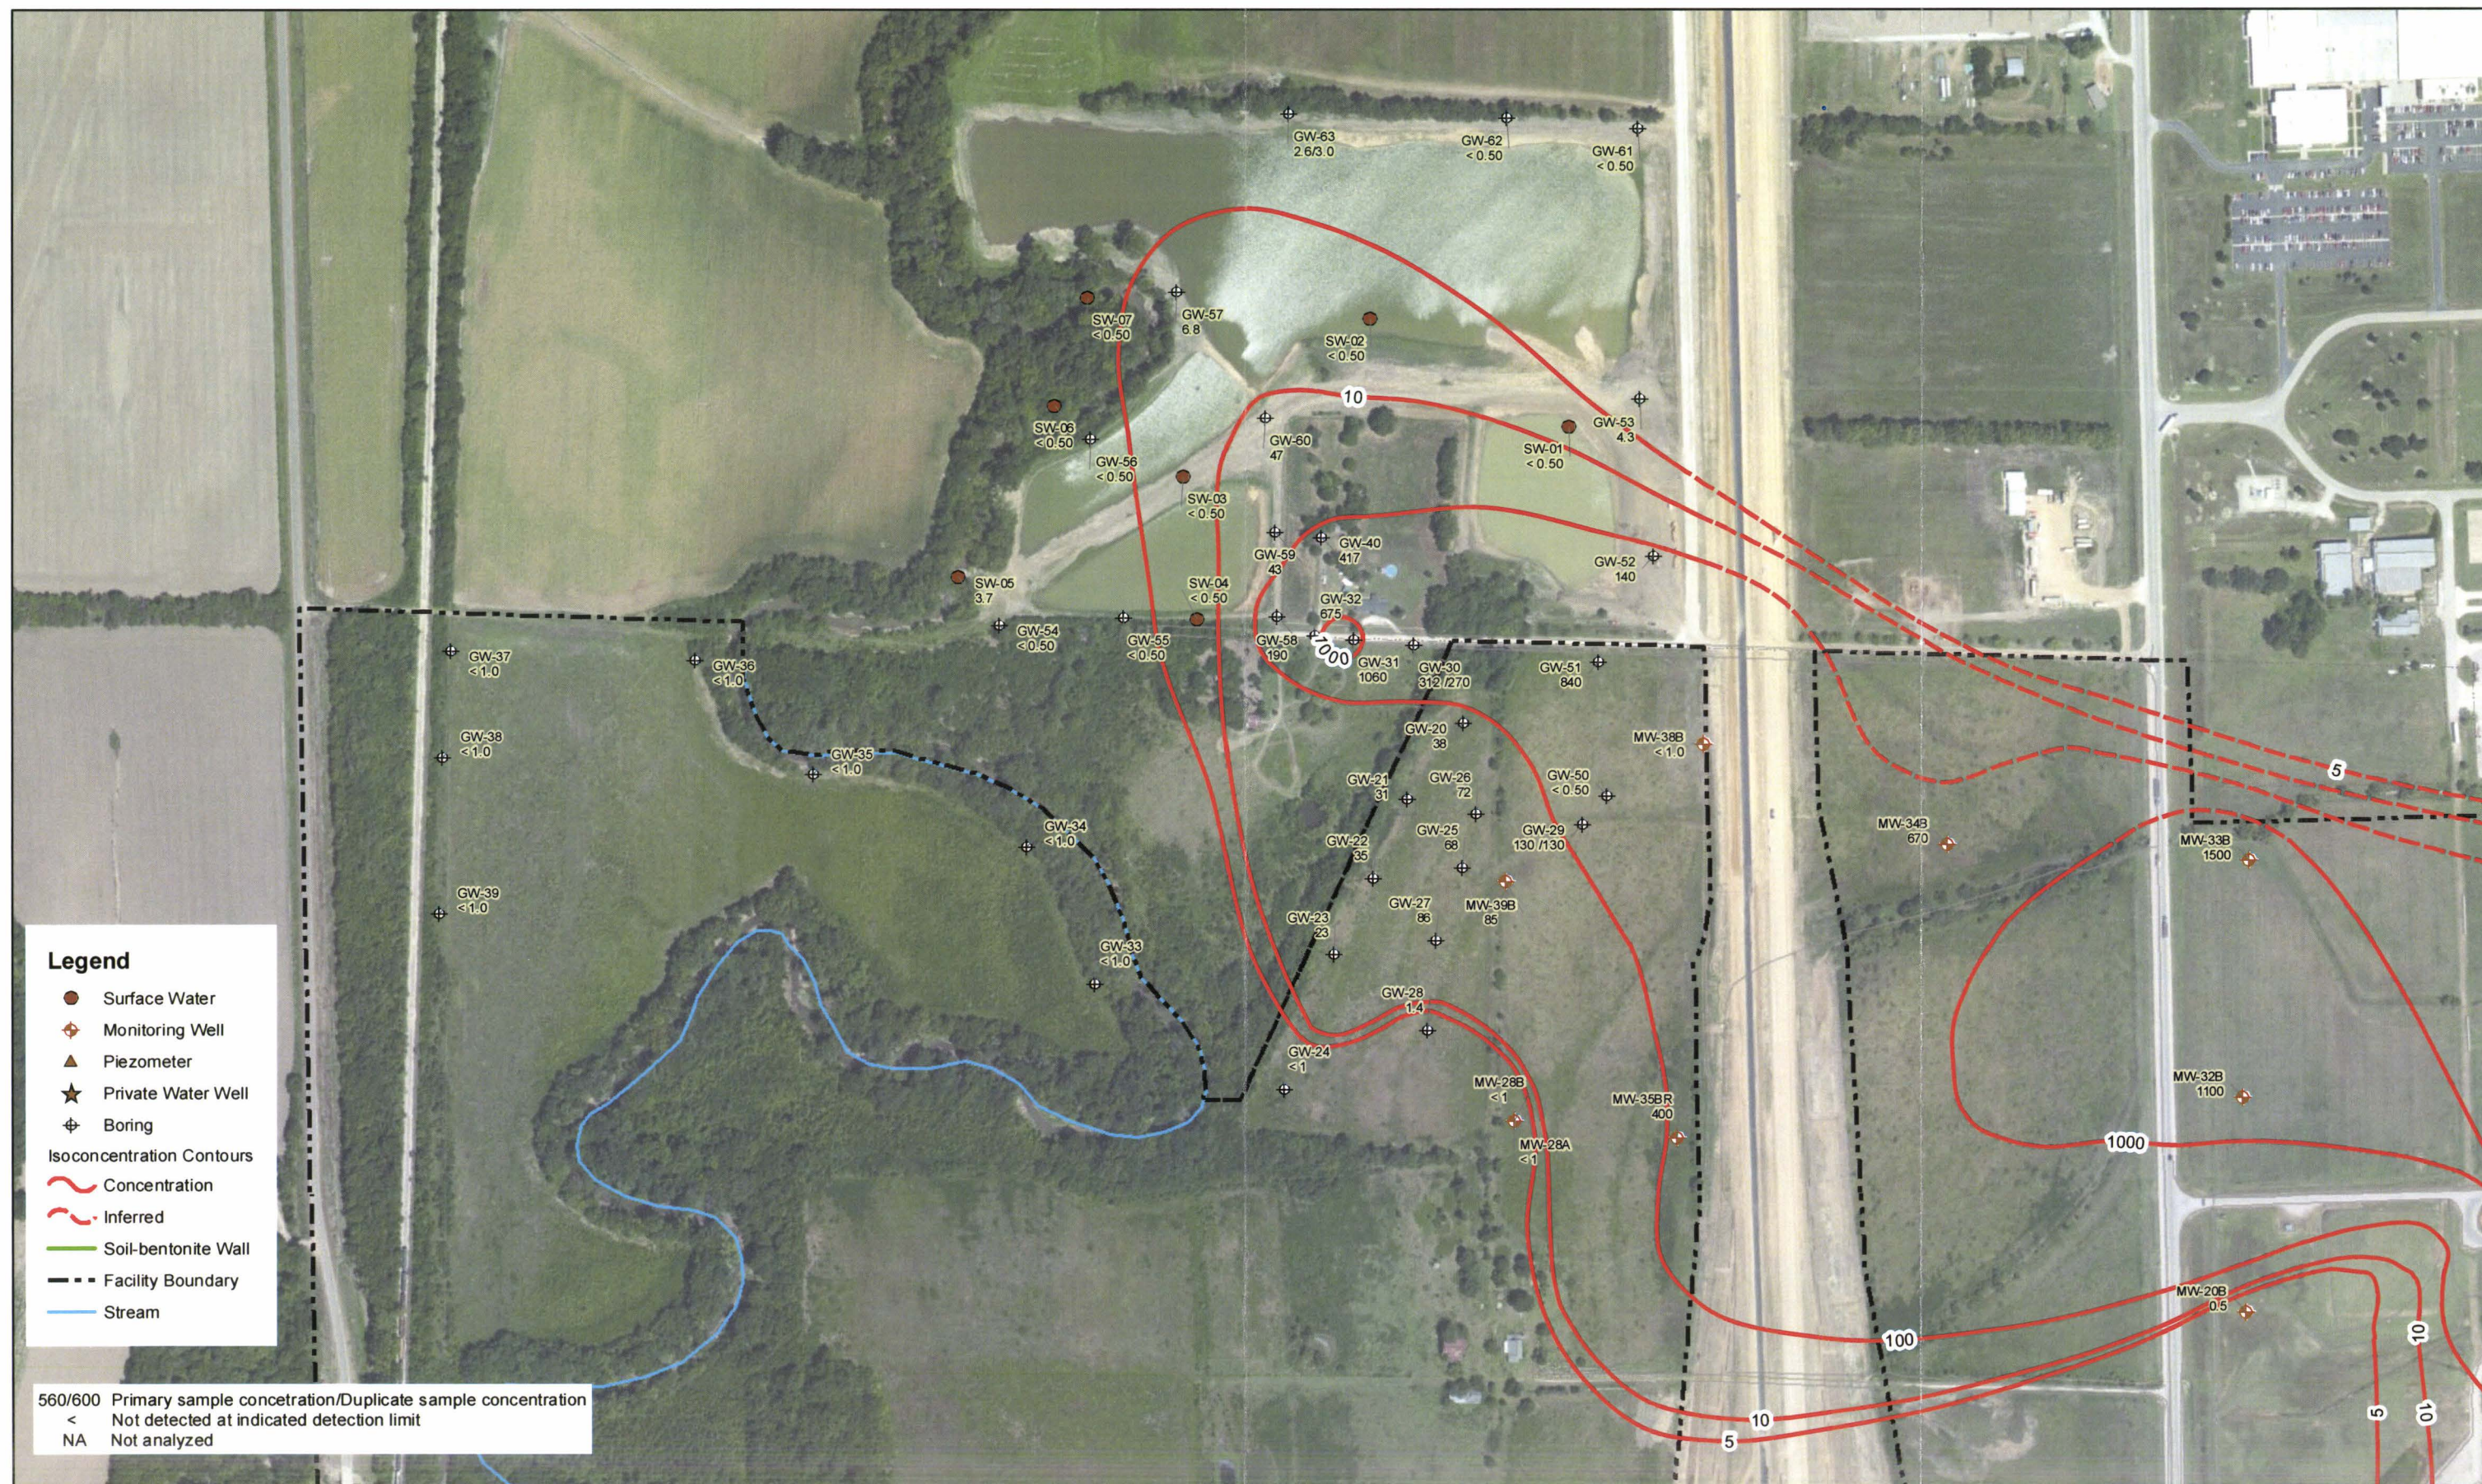
As illustrated in Figures 4-5, 4-12, and 4-13, the plume of dissolved VOCs was found to extend off-site to the north of Tract D, with concentrations of 1,1-DCE, PCE, and TCE exceeding their MCLs of 7 µg/L, 5 µg/L, and 5 µg/L, respectively. The highest concentrations were detected in three samples (GW-30, GW-31, and GW-32) collected in the ROW of County Road 2600, which runs east-west along the northern edge of Tract D. A sample from GW-31 contained 1,060 µg/L TCE and 127 µg/L PCE.
